Advisory on Flood Damaged Vehicles

Flood Damaged Car Restoration

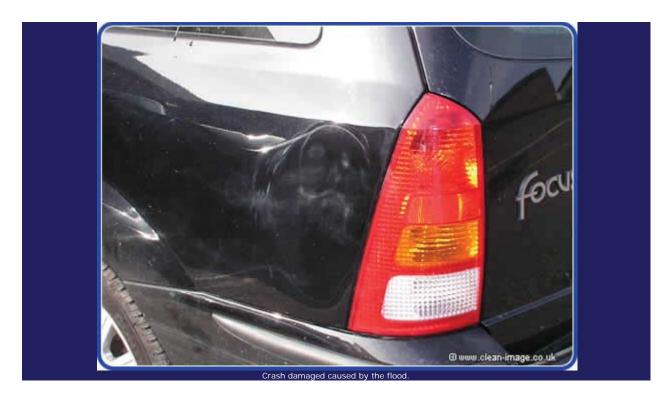
While the car was floating down the flooded road, it had sustained some minor crash damage (shown in photo above) and this problem was to be dealt with by a body shop after we had cleaned up the interior, so other than a wash to clean up the silt, there was no need for us to do anything with the exterior, the body shop would prefer to do this themselves.

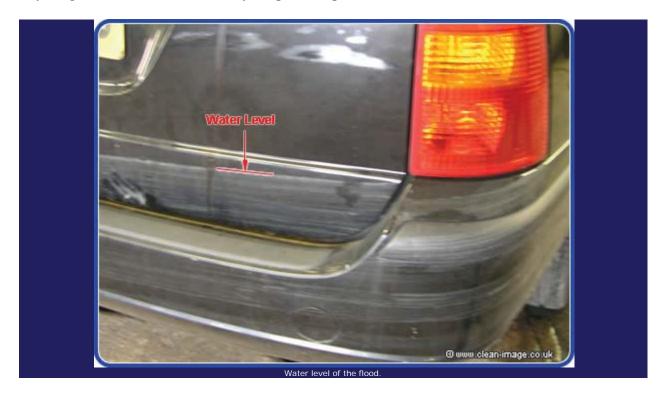
The photo (right) shows the 'tide marks' which are well above the level of the bottom doors and boot. The interior was filled with water, and although this water was clean when it left the water main, it had picked up plenty of mud and clay which made up a silt that coated everything.

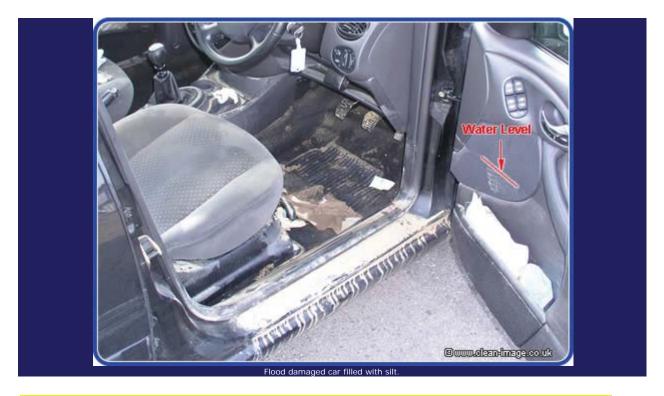
The water level was far above the level of the base of the seats, *but luckily below the level of most of the electrics*.

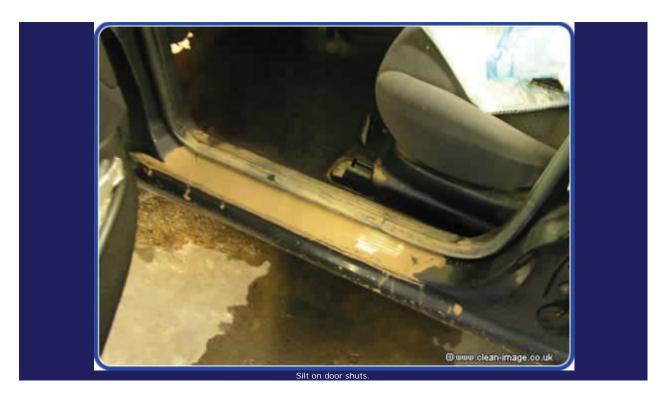
This above shows the silt on the door shuts. This amount of silt is also on the carpets and seats, to avoid any problems in the future with odours, this will all have to be washed out.

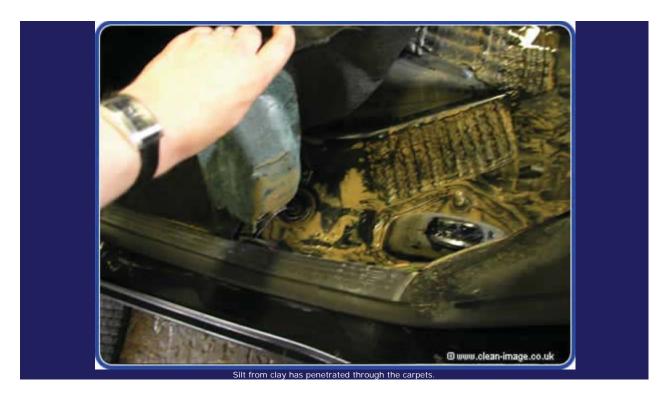
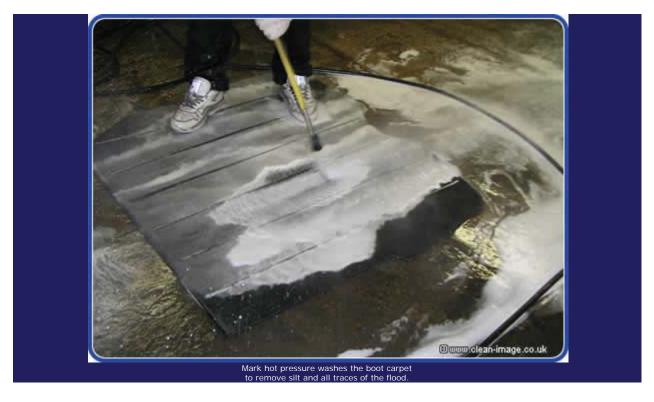
The photos above and below show the clay silt deposited by the flood water.

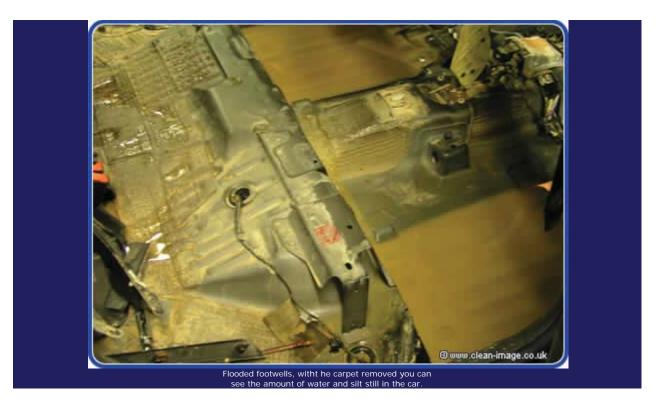
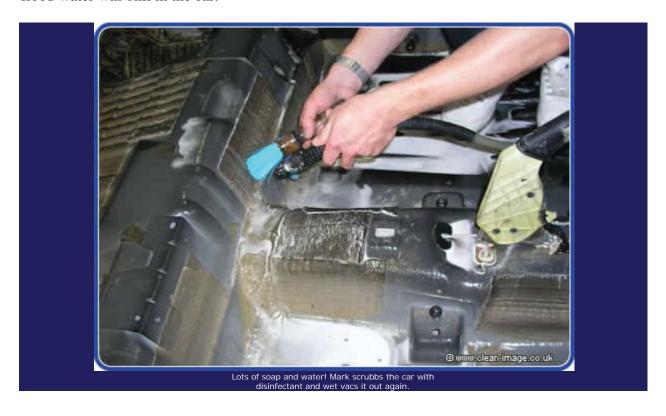
With seats and carpets removed, we were left with a bare shell that was full of dirty water (although disinfectant had already been added) The photos above and right show just how much flood water was still in the car.

We used an extractor (wet vacuum cleaner) to remove the water, and to wash the interior down further. Above you can see Mark working with a brush and soap spray.

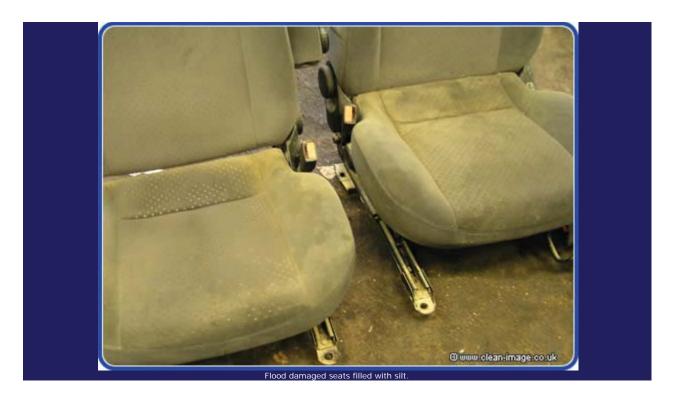
The above photo shows the state of the seats before washing. As these contained no electrical gizmos such as heating elements, air bags or sensors, we were able to flush them through with lots of water - giving them a shampoo isn't quite enough in these cases as they contain a lot of silt, plenty of hot water is the answer for flushing them through and washing the sediment away. Of course, we did shampoo them after we washed them. Luckily, the sponge padding inside the seat is molded and tends to have a rather smooth shiny surface that the silt won't penetrate.

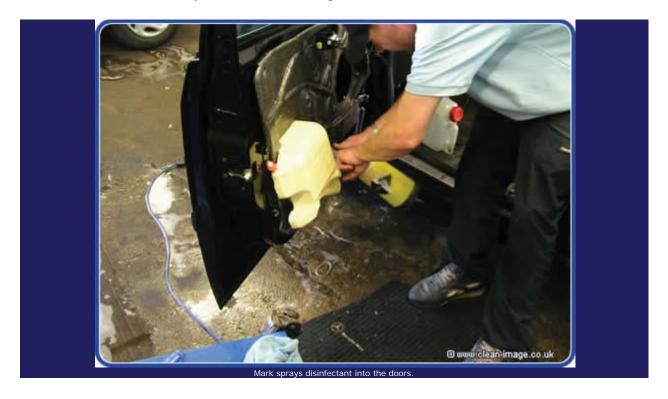
Although the door panels were sealed with a skin, flood water and silt had still managed to find it's way inside.

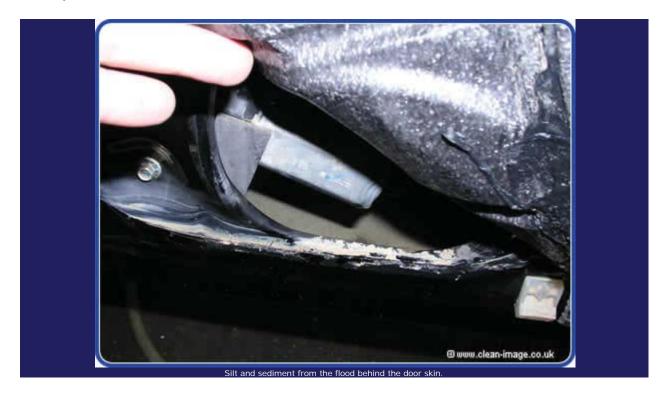
In the above photo, Mark pulls back the door skin to reveal the sediment - this too was cleaned and disinfected.

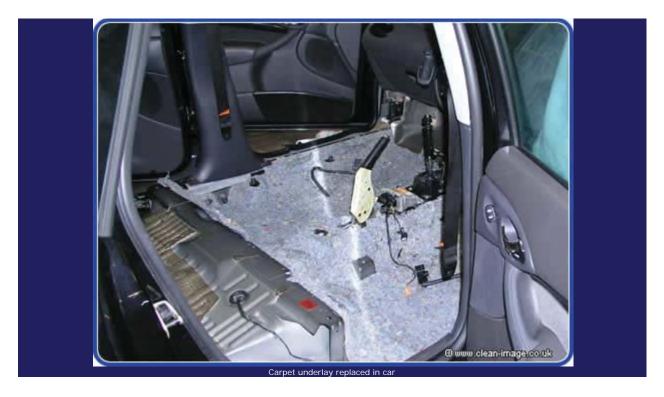
The photo above shows the carpet underlay in place, freshly cleaned and dried and as good as new.

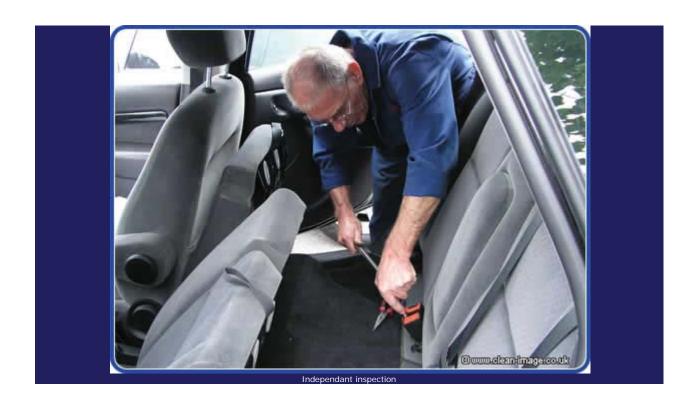
The final stage was to commission an inspection from an independent motor mechanic to ensure that we have put the car back together properly - the photo above shows David from Hemming & Reynolds checking the seatbelt fixtures with a torque wrench. Dave Hemmings has at least 45 years experience in motor repairs.
