Advisory on Flood Damaged Vehicles

Flood Damaged Car Restoration

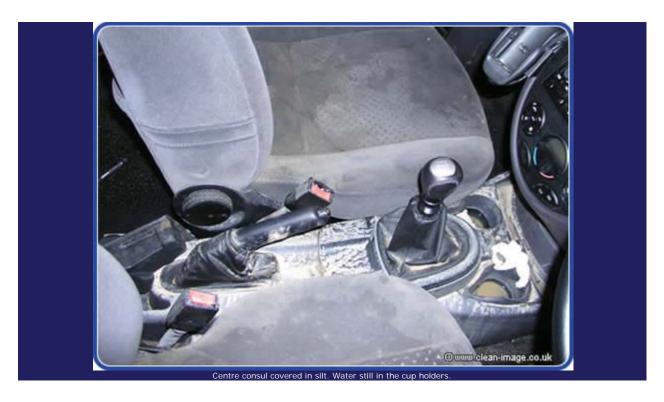
The water level was far above the level of the base of the seats, *but luckily below the level of most of the electrics*.

However, removing the silt is no easy task! To properly treat this car we need to take it apart piece-by-piece, clean it, disinfect it, and put it back together.

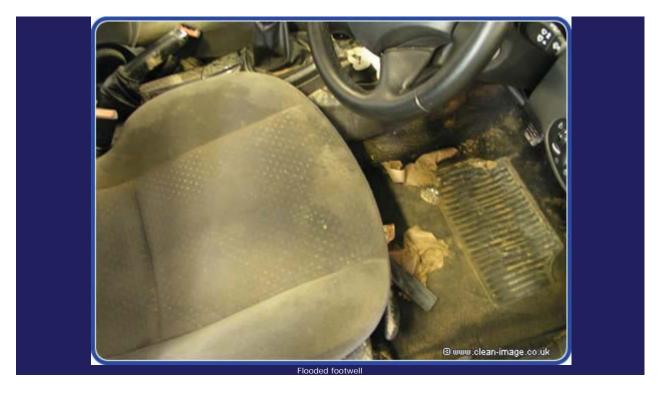
Everything in the car had become sodden, including maps and papers which had floated around and disintegrated.
